CLUB WEST PARKWAY TRAFFIC STUDY

July 8, 2013

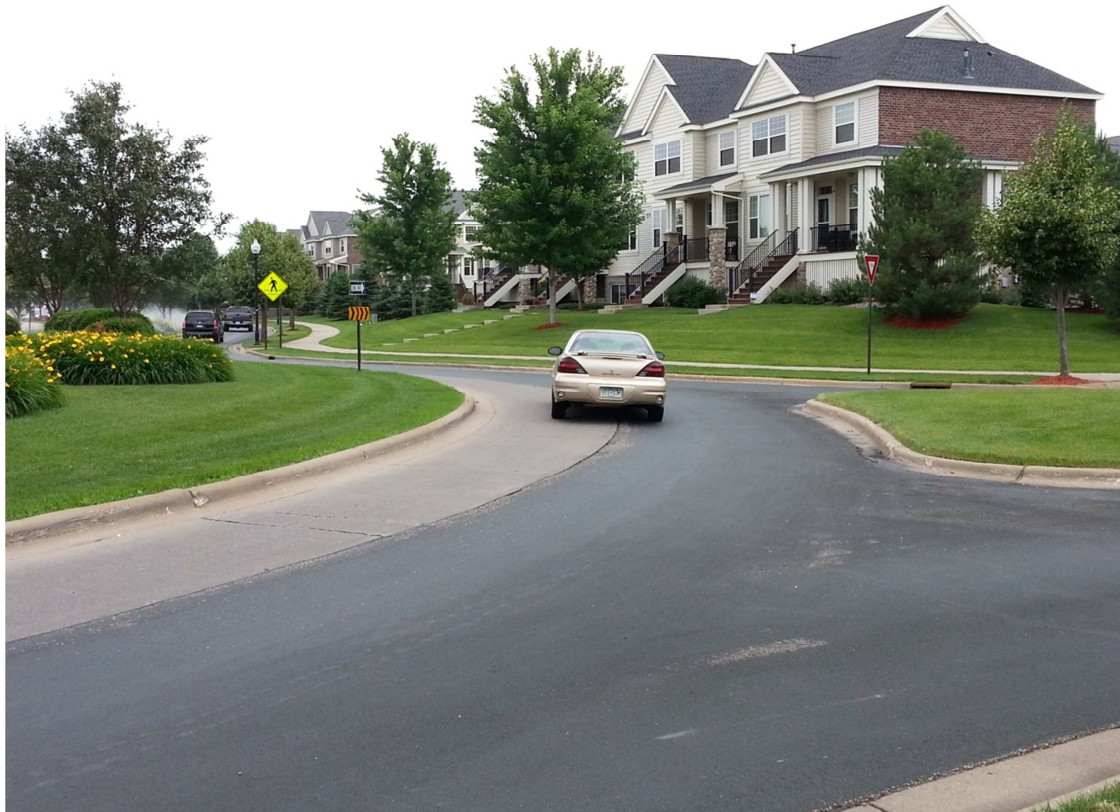
One issue that was observed is that vehicles are able to cut the inside corner on the roundabout because the outside edge of the inner concrete apron is not raised with a surmountable curb like it is on newer roundabout designs. By cutting the inside corner, vehicles are able to take a straighter path through the roundabout at a higher speed than intended.

Newer roundabout designs feature a surmountable curb which separates the inner apron from the drive lane. This creates an uncomfortable jolt or bump to a passenger vehicle trying to cut the inside corner, forcing them to take the intended drive lane and travel slower around the roundabout yet still allows large trucks and semi-trailers to easily navigate the roundabout using the apron for the trailer wheels.

If Council desires, staff could investigate modifying the apron in an attempt to discourage drivers from cutting the inside corner. Some potential modifications could include temporary speed bumps placed in the roundabout apron during non-winter months, cutting rumble strips into the existing apron, or removing the apron and replacing it with a raised apron. Even if additional measures were enacted to slow vehicles in the roundabout, there is no guarantee that it will prevent accidents or property damage to the trees and landscaping.

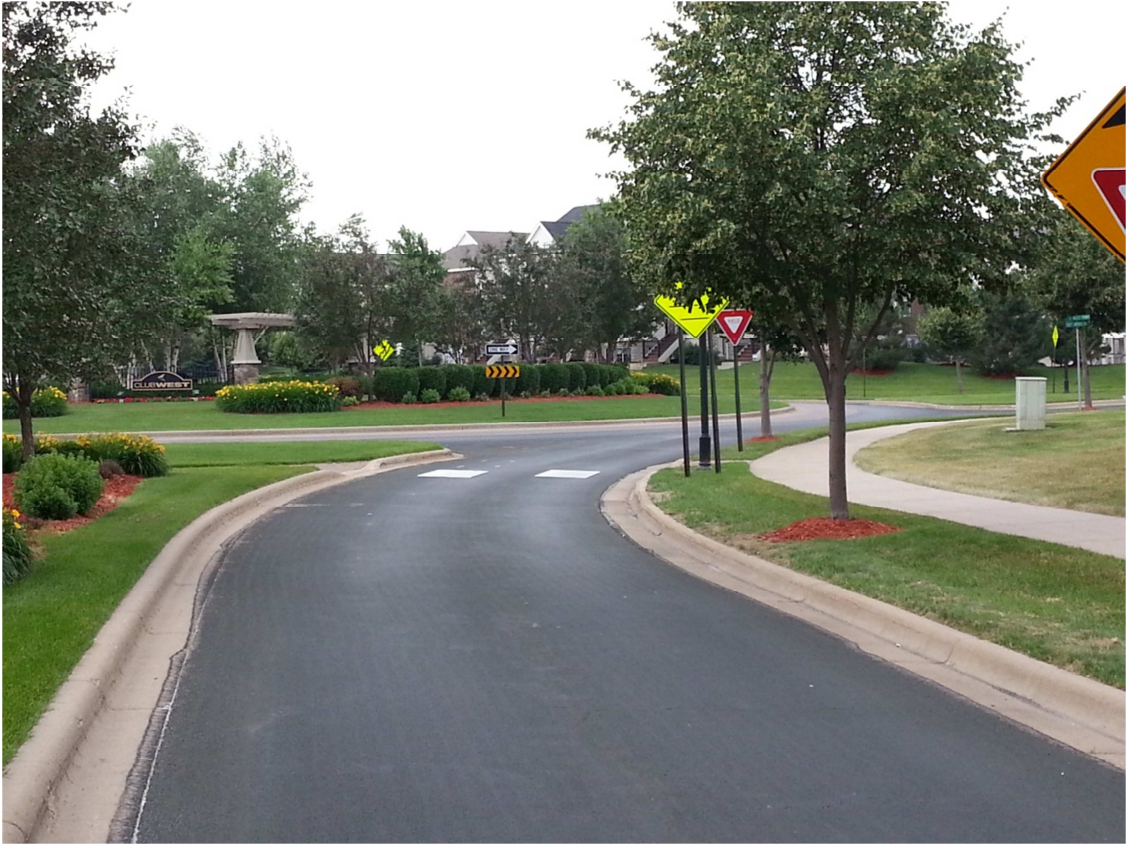
In 2009, staff studied the pedestrian crossings along Club West Parkway and presented a memo to Council at a workshop. The findings of that memo stated that certain additional signing and striping improvements could be made to increase the visibility of the crosswalks and those improvements were then done. At this time no additional crosswalk signage or striping is recommended. One recommended action is for the Club West association to have their landscape

maintenance company trim trees where needed to make the crosswalk signs more visible to motorists as shown below.
