TIF ANALYSIS FINDINGS FOR RAINBOW FOODS AT 551 87TH LANE NE

LHB was hired to inspect the Rainbow Foods building located in a shopping mall at 551 87th Lane NE in Blaine, Minnesota, to determine if it meets the definition of "Substandard" as defined by *Minnesota Statutes, Section 469.174, subdivision 10.* The building parcel may potentially be part of a future Redevelopment TIF District, so will need to be compliant with all the statutes pertaining to a Redevelopment District.

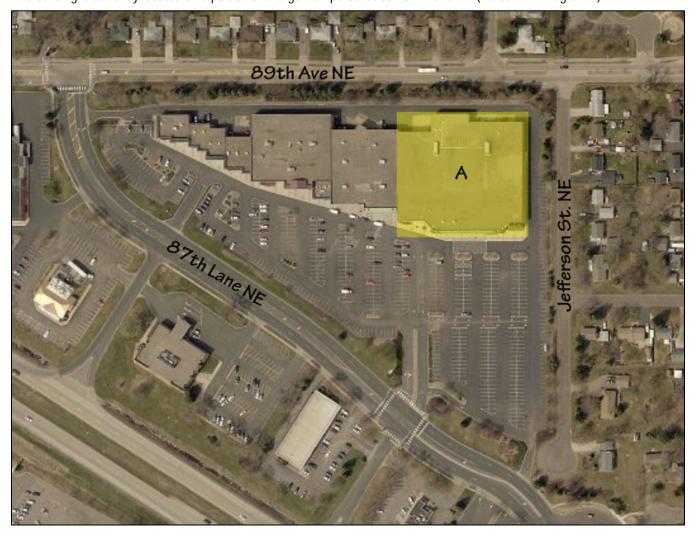
Diagram 1

The building is currently located on a portion of a large mall parcel at 551 87th Lane NE (Parcel A in Diagram 1).
