Report of Inspection Procedures and Results for  
Determining Qualifications of a  
Tax Increment Financing District as a Redevelopment District

## Blaine University Avenue Redevelopment TIF District Blaine, Minnesota

September 6, 2018

Prepared For the  
**City of Blaine**

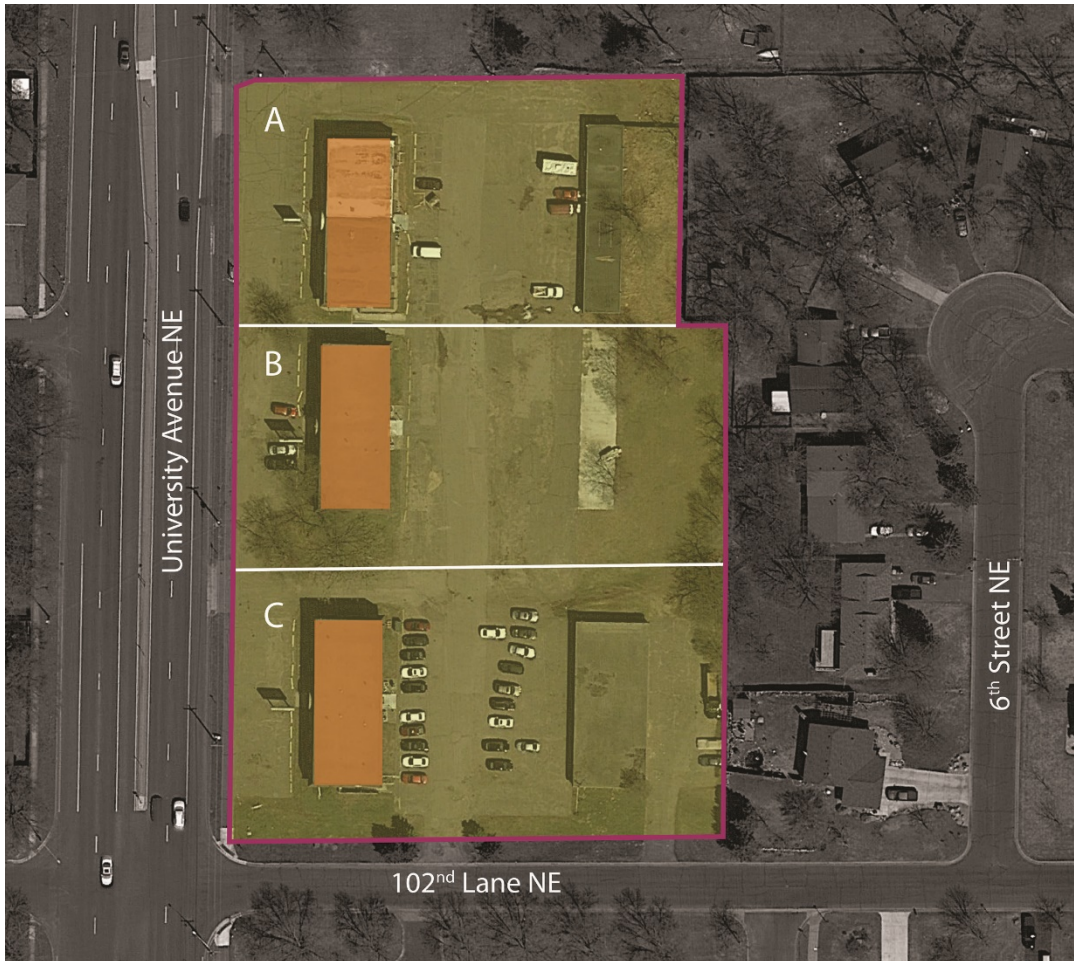
**Diagram 3 – Substandard Buildings**

Shaded green area depicts parcels with buildings.  
Shaded orange area depicts substandard buildings.

The parcels with substandard buildings are reasonably distributed compared to all parcels that contain buildings.
